**Submitted by:**  
Jp2g Consultants Inc.  
1150 Morrison Drive, Suite 410  
Ottawa, ON K2H 8S9  
T 613.828.7800  
Jp2g Project Number: 21-5066A

# Flood Risk Assessment Study

## Background Report - DRAFT

**Prepared for: The Township of Whitewater Region**  
44 Main Street  
Cobden, Ontario K0J 1K0

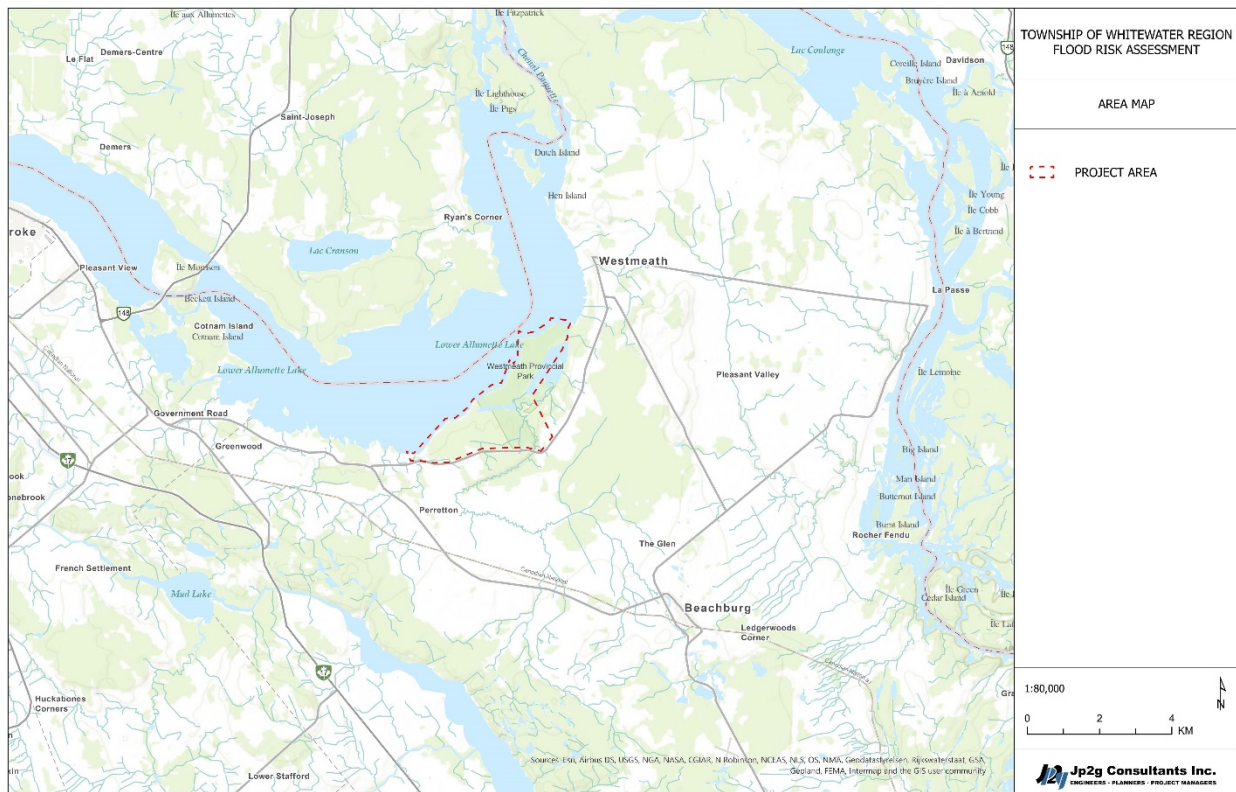
Figure 1: Study Area Location

The study area is south-west of the Westmeath Provincial Park along the Ottawa River, which includes a Provincially Significant Wetland and some grandfathered properties situated in the floodway or flood fringe. The study area is illustrated in **Figure 1** below. The study area is bound by the Ottawa River to the north, Westmeath Provincial Park to the east, Westmeath Road (County Road 12) to the south, and west of Moores Beach Road to the west.

The area comprises 105 properties, from the area west of the Westmeath Provincial Park along the Ottawa River from Greatview Trail to Moore’s Beach Road, including Sunset Trail, Edgewater Trail, McWitt Trail and Sand Point Road.
